MARINE INVESTIGATION REPORT

M99C0048

SWAMPING AND SINKING WITH LOSS OF LIFE

UNNAMED OPEN-SKIFF COMMERCIAL FISHING VESSEL
OFF HNAUSA HARBOUR, MANITOBA

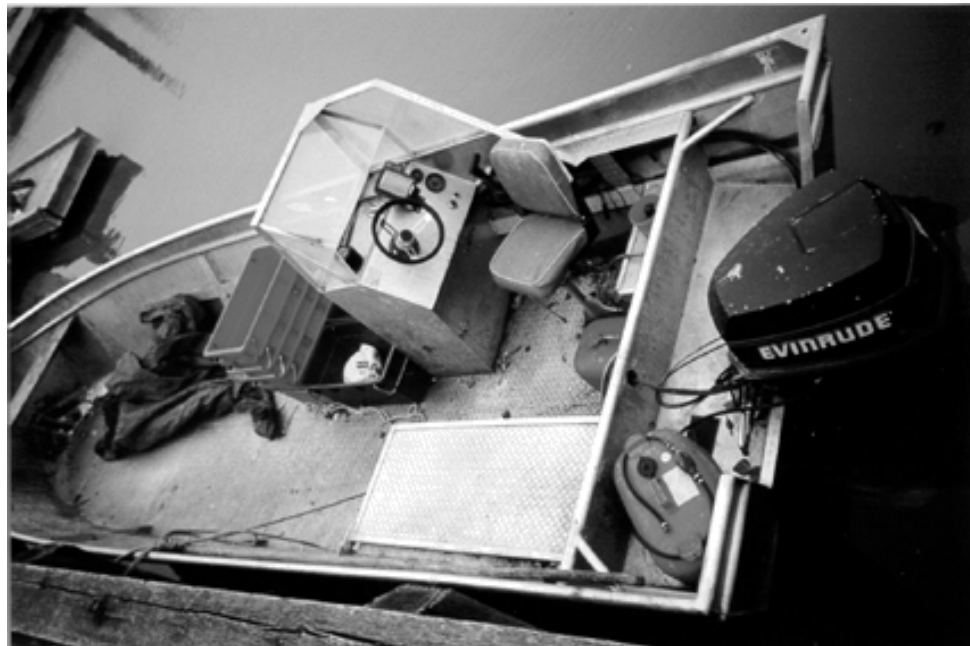
Those working forward, at the horn, could not see how much water had accumulated at the stern due to the open seacock and shipped water, because fish crates obstructed the view aft. The water shipped over the bow from the second large wave ran aft and its weight caused the vessel to further trim by the stern, markedly reducing the remaining reserve buoyancy to the point where the vessel downflooded and quickly sank by the stern.

Overview showing fish crates

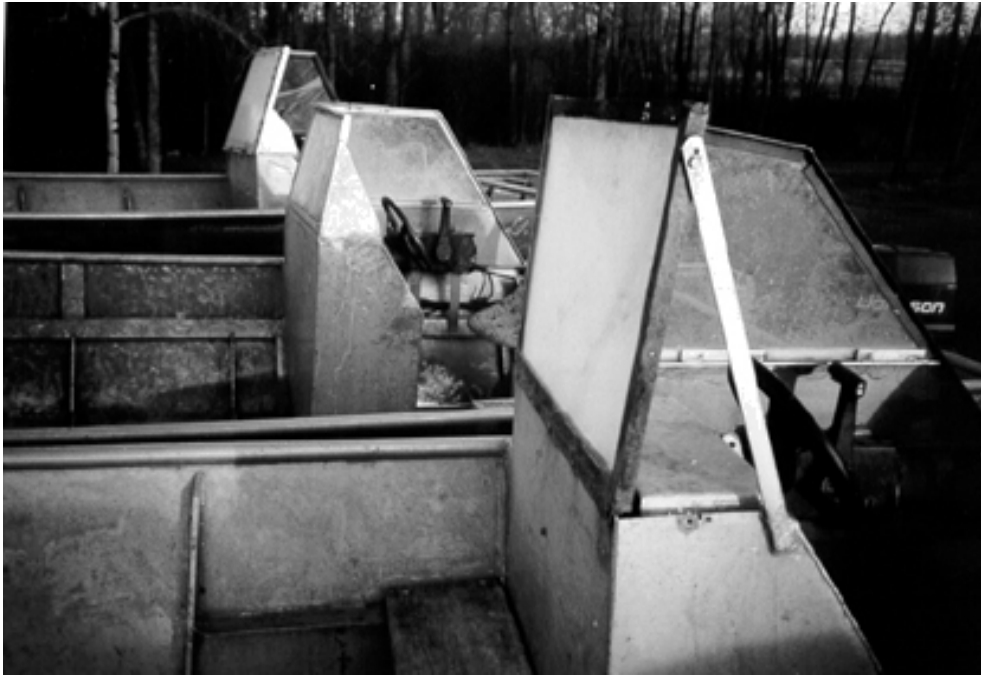
A split steering control console was located about 2.5 m from the stern. At the deep well aft, near the motor, was an extended spindle with a handle, which was broken, connected to a gate valve below, at deck level. At the valve there was a second handle to close and open the valve. While the vessel is underway the gate valve may be opened to drain the vessel. When the vessel is not making way through the water, water will flood the hull if the valve is open. On 23 October 1999, the valve was initially reported as closed from the morning until the time of the occurrence. However, subsequent information indicated that it had been opened while travelling between gangs of nets.

Typical split-console engine control station

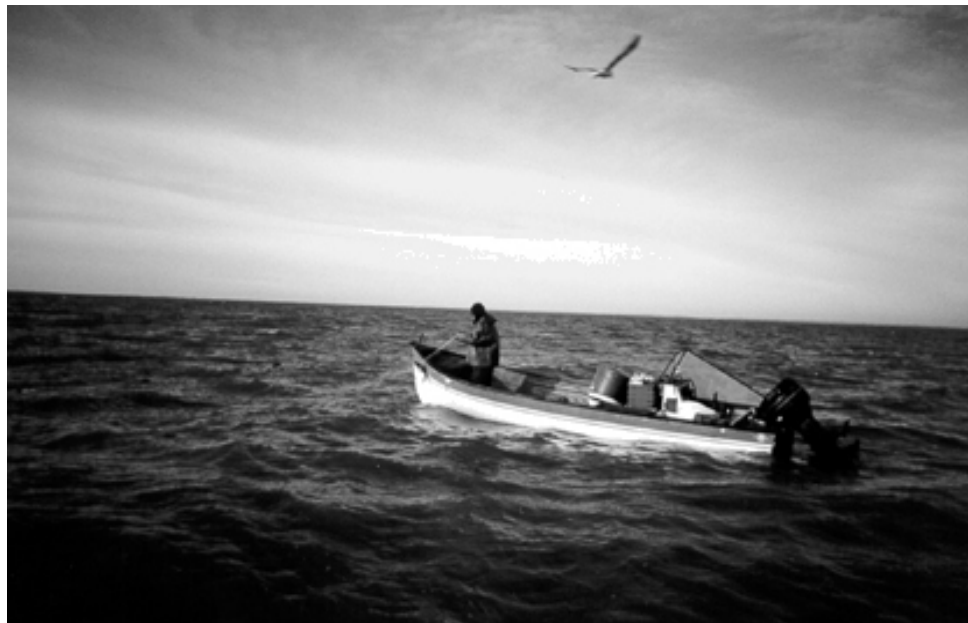
A fisher gill netting.
